Manhole Inspection Summary

Manhole # S25II1041MH

Location Address: **4204 ROLAND AVE** Cross Street: **PROVIDENCE ST**

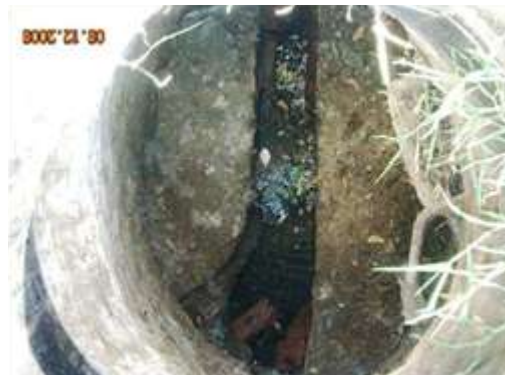
Top View

Evidence of surcharge - Bench debris.
Channel debris.

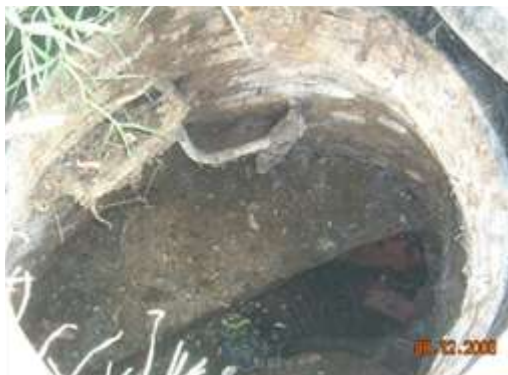
Defect

Frame leaks. Adjustment deterioration
and infiltration. Corbel and Barrel
infiltration.

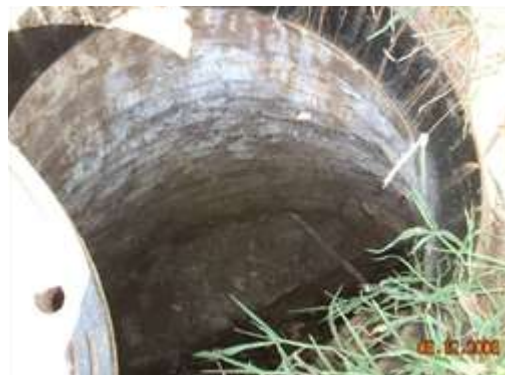
Defect

Frame leaks. Adjustment deterioration
and infiltration. Corbel and Barrel
infiltration - other side.

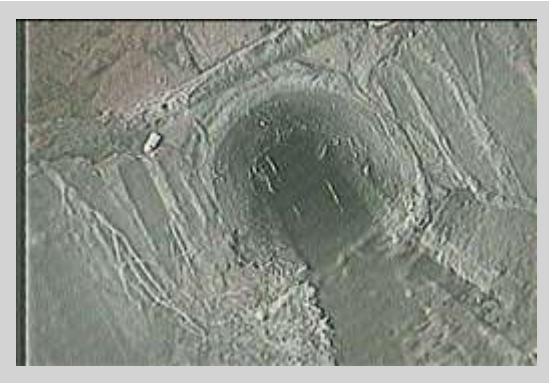
6 in. Circular Gravity Sewer Pipe Out @ 12 O'Clock

Bench and Channel root intrusion.

Infiltration: **Evidence** Pipe Seal Cond: **Cracked**

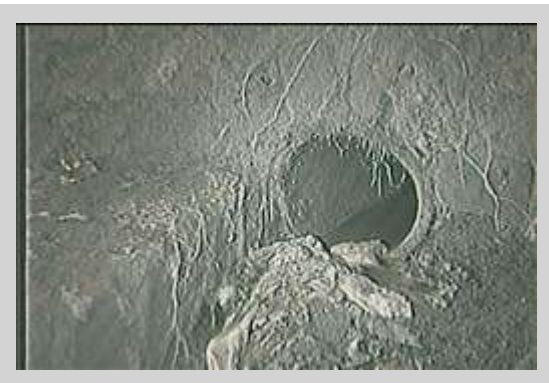
6 in. Circular Gravity Sewer Pipe In @ 6 O'Clock

Barrel deterioration, root intrusion and infiltration.

Infiltration: **Evidence** Pipe Seal Cond: **Roots**

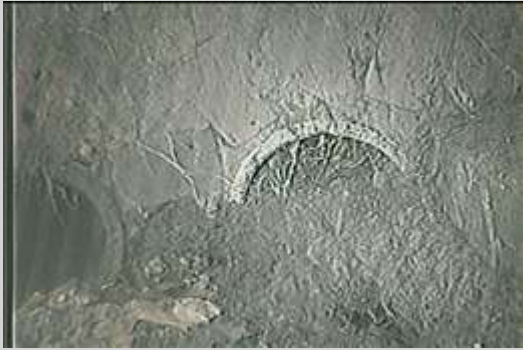
Pipe In @ 7 O'Clock

Deposits: ☐ None ☒ **Mud** ☐ Sludge ☒ **Debris** ☐ Grease

Silt Depth: **6** (in.)

Deposits Extent: **Heavy**
